# Board of Education Capital Plan FY17-FY21

**PROJECT TITLE:** Birch Grove Primary School Roof Sections A-H

BIRCH GROVE SCHOOL  
247 RHODES ROAD  
TOLLAND, CT

**Birch Grove School  
247 Rhodes Road  
Tolland, CT**

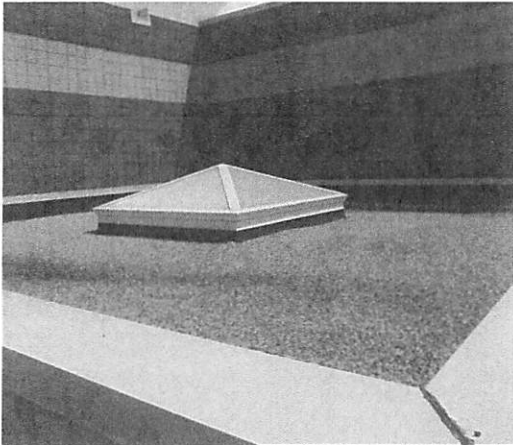
Photo #1: Sections I, J and K were re-roofed in 2003, the roofs appear to be in good sound condition

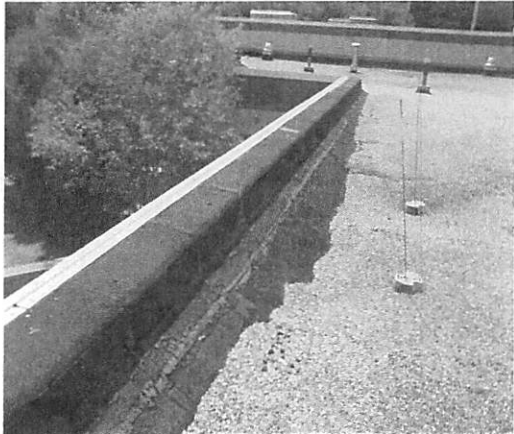
Photo #2: View of the uncoated wall flashings facing North on Section C

- Numerous openings in the parapet wall flashings
- Eroded felts throughout
- Some leaks with the masonry on the Gym Storage area, weep holes need to be cleared
- Some of the flashings need to be coated an aluminum coating
- Pitch boxes need to be topped off

- 1) Repair perimeter flashings as required
- 2) Repair all eroded felts as required
- 3) Repair opening in flashings

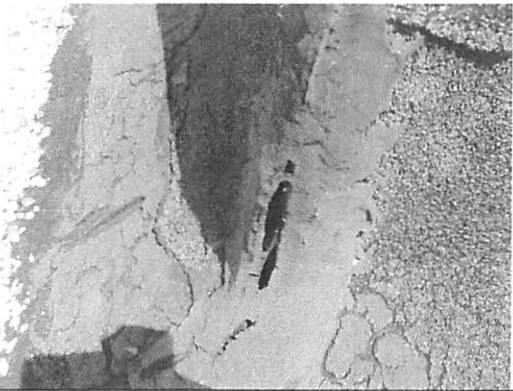
Photo #3: Openings of the parapet wall flashings

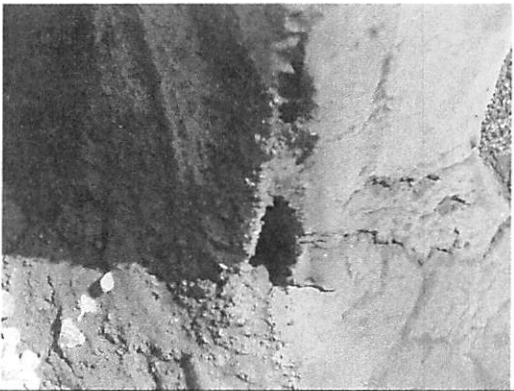
Photo #4: Another opening in the parapet on Section C

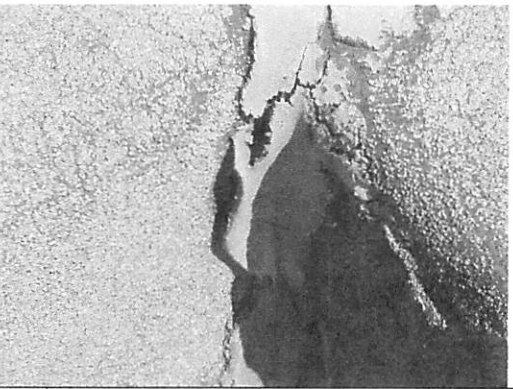
Photo #5: More openings along the flashings on Section A.

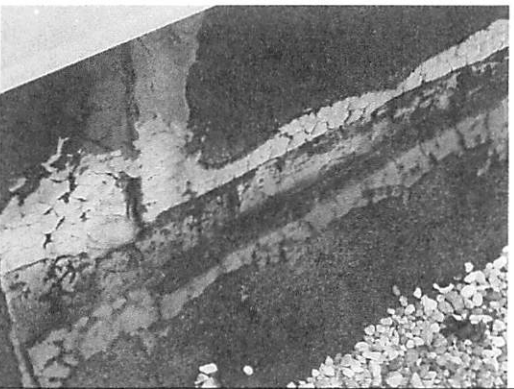
Photo #6: Flashing membrane has slid down along the parapet
